# Manhole Inspection Summary

Manhole # S29I\_\_028MH

Insp Date: **1/22/09 1:02 PM**

**Location** Address: **111 Lemmon St.**

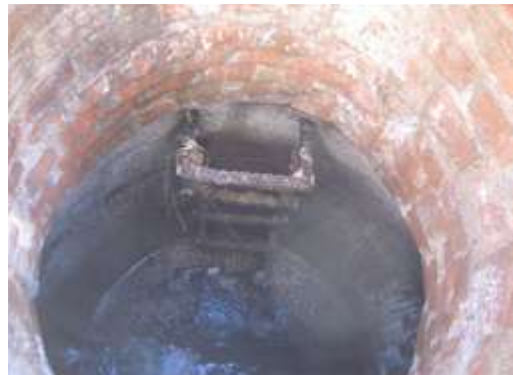
Defect 2

Infiltration: ☐ None ☒ **Joint** ☐ Cracks ☒ **Mortar** ☐ Roots ☐ Wall

Infiltration: ☐ None ☒ **Joint** ☐ Cracks ☐ Mortar ☐ Roots ☐ Wall

**Surcharge** ☒ **Evidence Of Surcharge** Depth: **5** (ft.) ☐ Active Surcharge Present

corbel joint infiltration, surcharge evidence

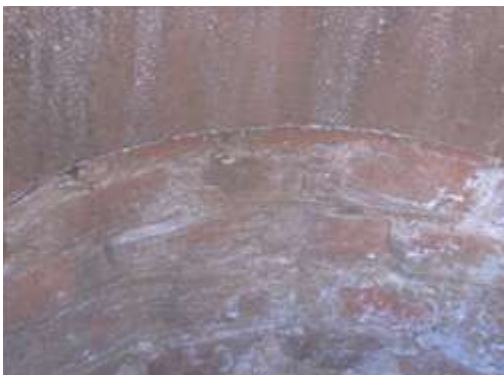
Defect 1

Condition: ☐ Sound ☐ Cracked ☐ Root Intrusion ☐ Loose Brick ☒ **Deteriorated**

chimney deteriorated with mortar & joint infiltration

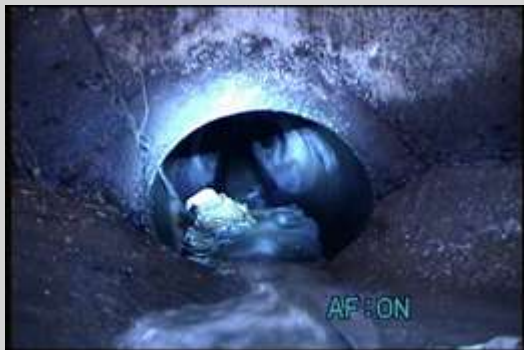
12 O'Clock Outflow

10 in. Circular Gravity Sewer  
Pipe Out @ 12 O'Clock

Pipe Height: **10.8** (in.) Rod and Bar (Angled)  
Pipe Material: **Clay** ☐ Pipe Lined  
Invert Depth: **7.94** (ft.) Flow Characteristics: **Fast**  
Deposits: ☒ None ☐ Mud ☐ Sludge ☐ Debris ☐ Grease  
Silt Depth: **0** (in.) Deposits Extent:  
Infiltration: **None** Pipe Seal Cond: **Sound**

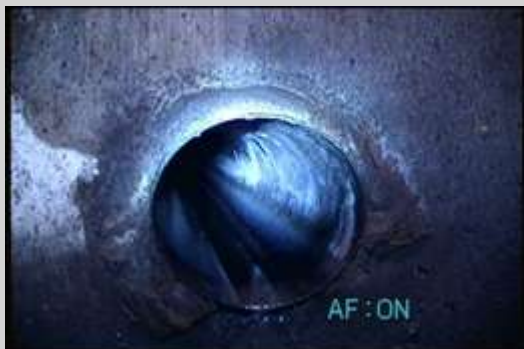
3 O'Clock Inflow

10 in. Circular Gravity Sewer  
Pipe In @ 3 O'Clock

Pipe Height: **10.8** (in.) Rod and Bar (Angled)  
Pipe Material: **Clay** ☐ Pipe Lined  
Invert Depth: **7.06** (ft.) Flow Characteristics: **None**  
Deposits: ☒ None ☐ Mud ☐ Sludge ☐ Debris ☐ Grease  
Silt Depth: **0** (in.) Deposits Extent:  
Infiltration: **None** Pipe Seal Cond: **Sound**

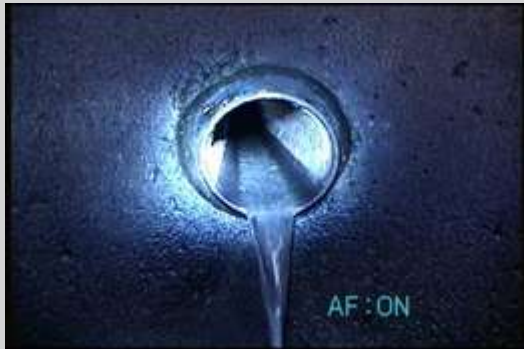
6 O'Clock Inflow

6 in. Circular Gravity Sewer  
Pipe In @ 6 O'Clock

Pipe Height: **6** (in.) Rod and Bar (Angled)

Pipe Material: **Clay** ☐ Pipe Lined

Invert Depth: **6.52** (ft.) Flow Characteristics: **Fast**

Infiltration: **None**

Pipe Seal Cond: **Sound**
